Dry Gas Sealing Systems for Oil Sands Pumping Applications

Design Engineering Issues and Resolutions

By: Chandra Sivapuram, P.Eng.

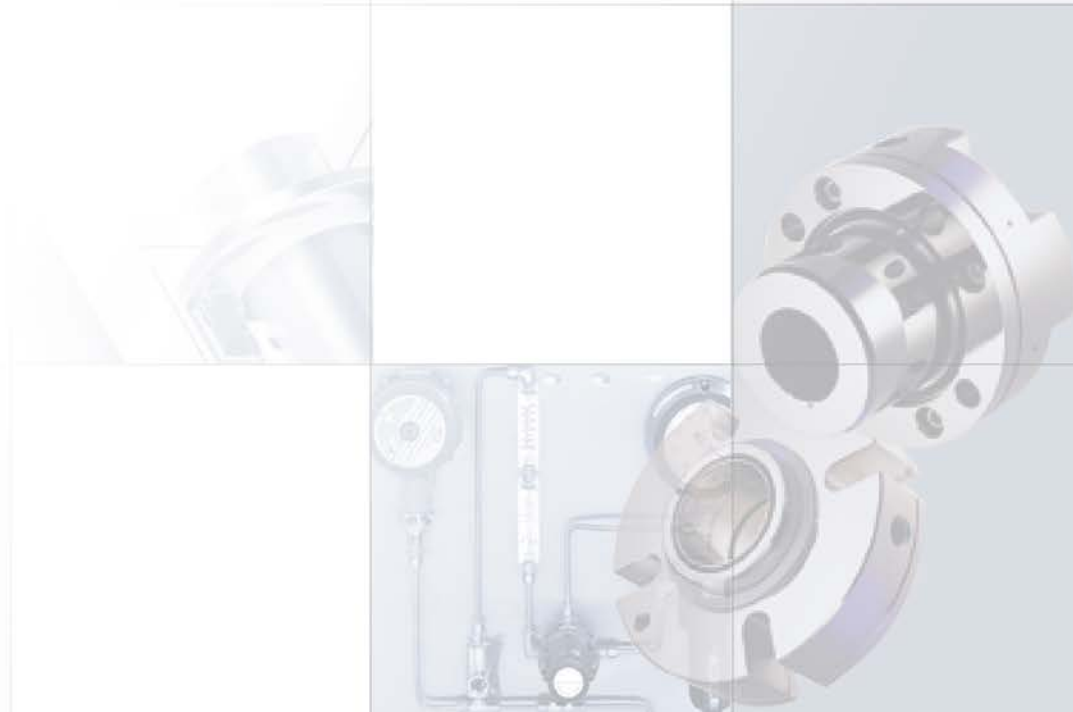
Nitrogen supplied through external source to Dry Gas Seals contaminated with water and pipe rust, causing the filters to plug and the filter cartridges to rupture and the seals to flood with water and debris.

- Proper nitrogen line flushing (remove filter cartridge & Flow meter during flushing)
- Install dual filter with DP gauge, and provision for on-line filter cartridge replacement

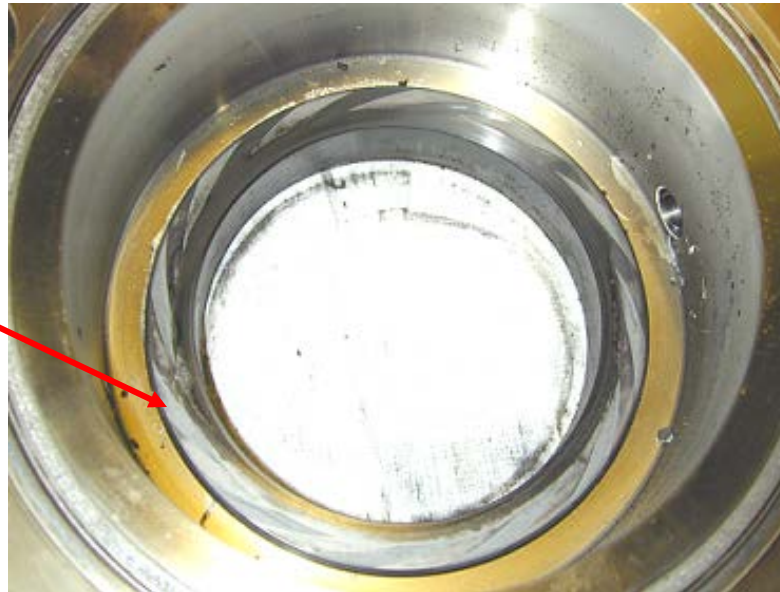
Outboard mating ring
and seal chamber
with debris

- *Seal did not exhibit any signs of serious face contact.*
- *Tremendous amount of debris inside the seal chamber foreign to any material used in the seal.*
- *Source of contamination was the nitrogen supply system.*

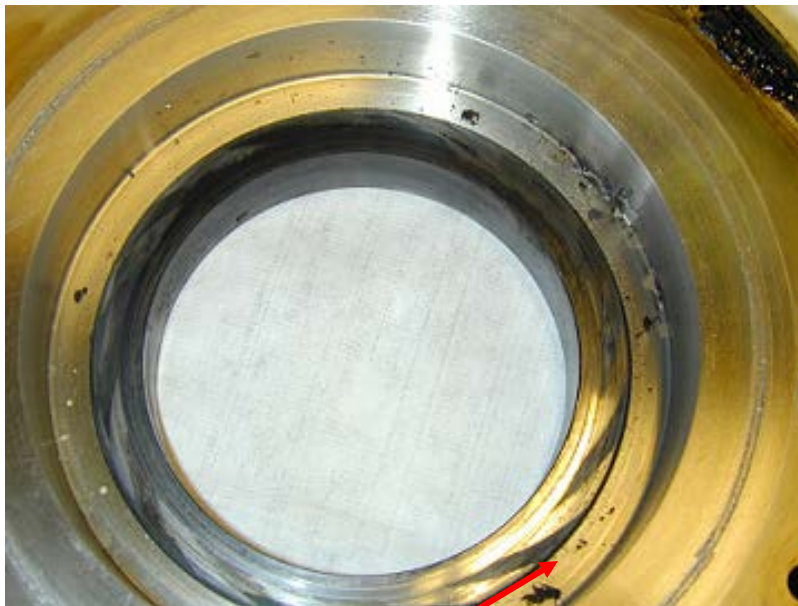
Inboard mating ring & seal chamber with debris

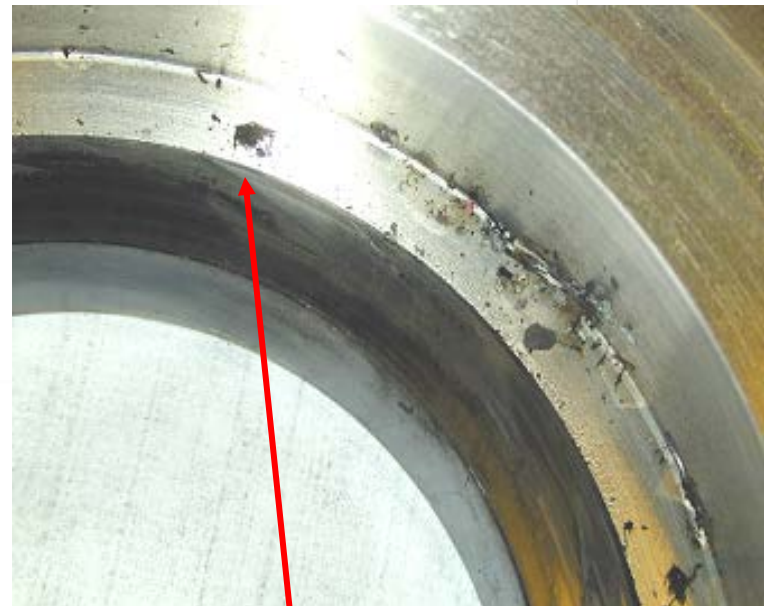
Foreign debris from nitrogen supply system

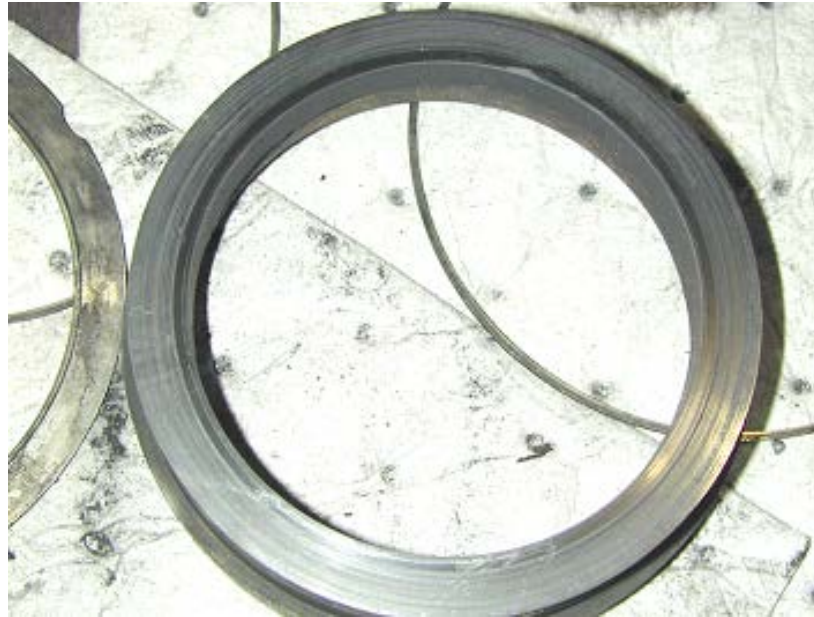
- *The cavity of the mechanical seal did not show any indication of product.*
- *Other than a massive amount of seal face materials, there was no residue of process fluid inside*

- Program VFD minimum speed at 1550 RPM and maximum speed at 2300 RPM.
- Install RTDs on seal faces to record the seal face temperature and predict seal failures

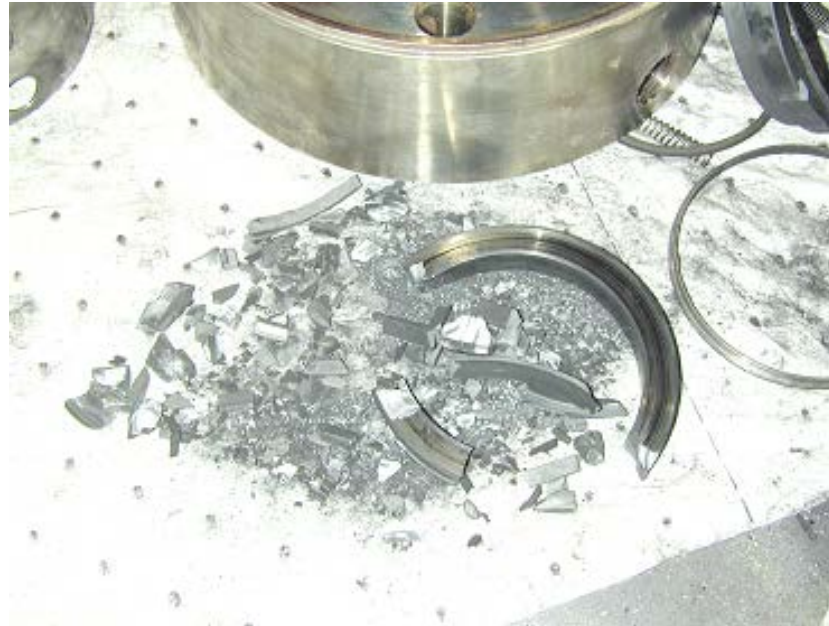
- *The outboard seal faces were virtually destroyed. The silicon carbide mating ring was in several pieces. Half of it was broken down to small debris.*

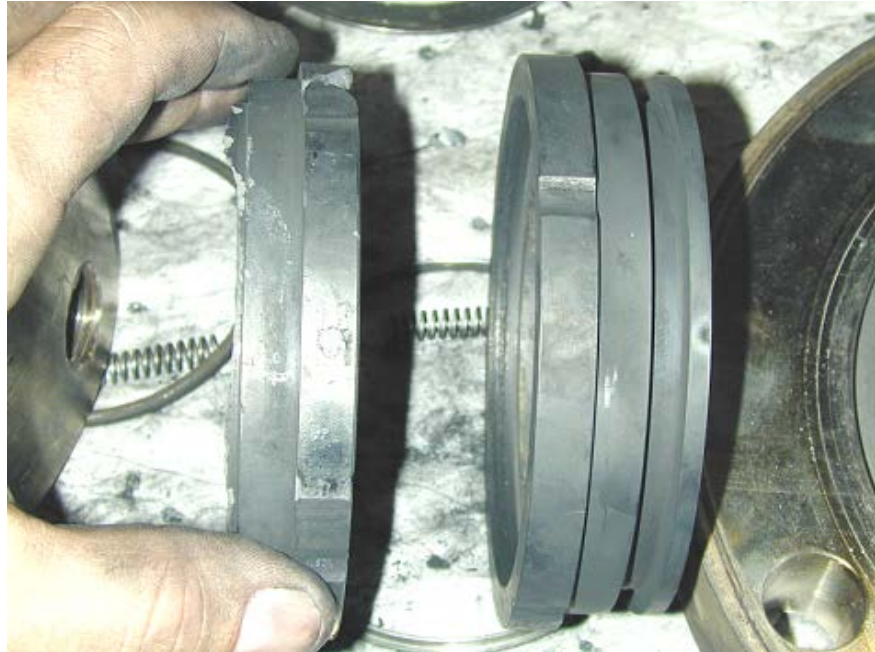
The inboard carbon primary ring seal face completely worn off.

- Severe o-ring degradation on both the stationary and rotating seal heads.
- Temperatures in excess of maximum design temperature (204C) obtained.
- The theory on why the outboard set of seal face failed first, is because they are exposed to the greatest differential pressure (965kPa) and more prominent to make contact with each other when an upset condition has occurred.
- When the seal faces make contact, the face grooves wear off, removing the pressure dam technology designed to lift off the seal faces from one another. The seals remain in contact during dynamic operation until catastrophic failure.
- The installation Resistance Temperature Detection Sensors in the seal gland provides accurate measure of the seal face temperature and alleviates catastrophic seal failure.

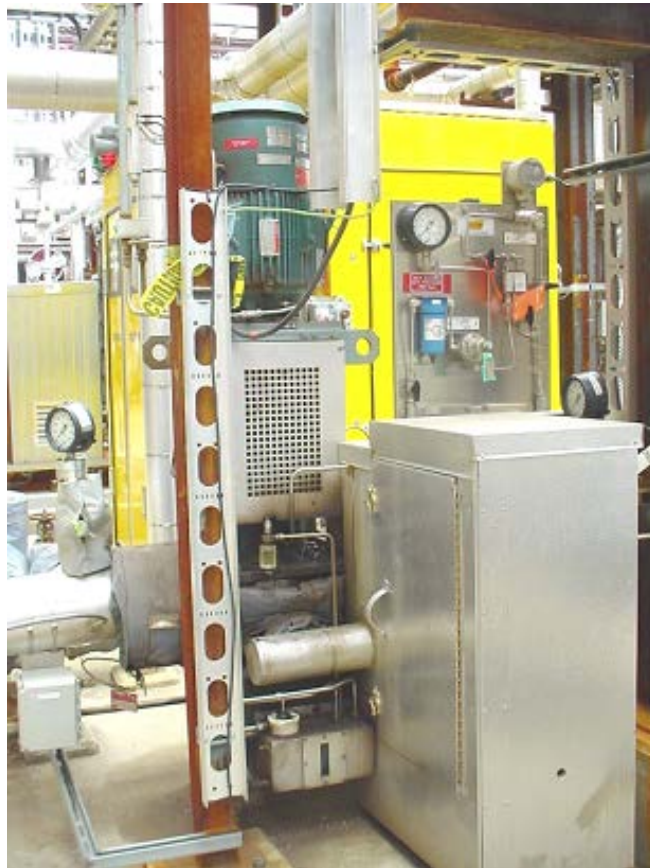
- Typical vertical in-line pumps with stand-by pump arrangement involves one pump in operation and second pump in stand-by mode.
- When pump is not running, the pump is filled with nitrogen through the seal pushing the process liquid out of the pump casing. Starting the pump in this condition will cause pump failures due to dry running
- Continuous run in this mode causes pump seal failures or seizure.

Install vent lines from pump casing of vertical pumps to an elevated point on the suction side of the pump or safe location.

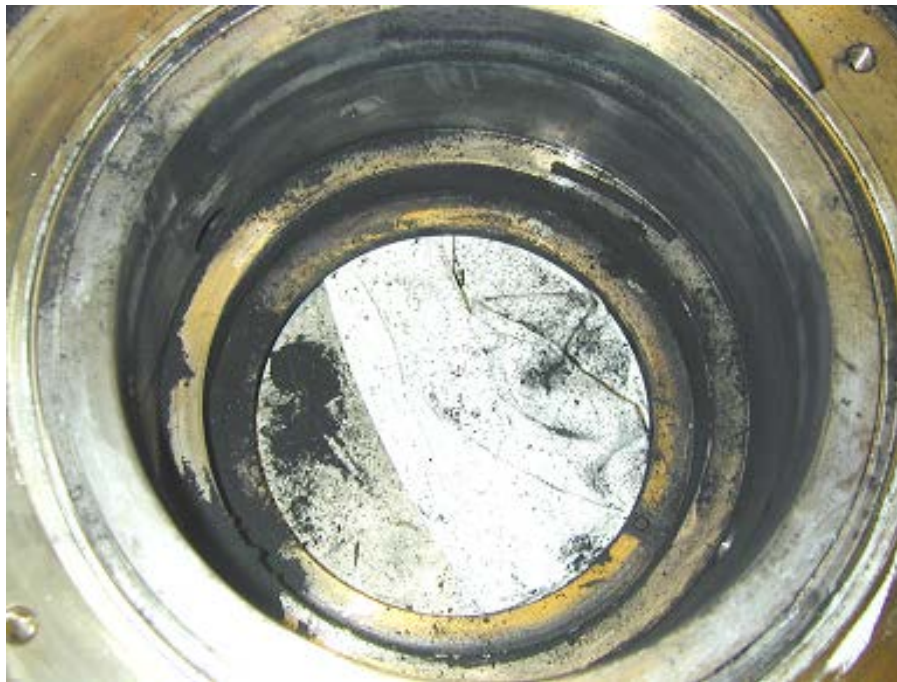
Carbon dust contamination inside seal chamber due to dynamic face contact with silicon carbide seal face

- New procedure and guidelines to maintain stable flow to avoid frequent seal failures.

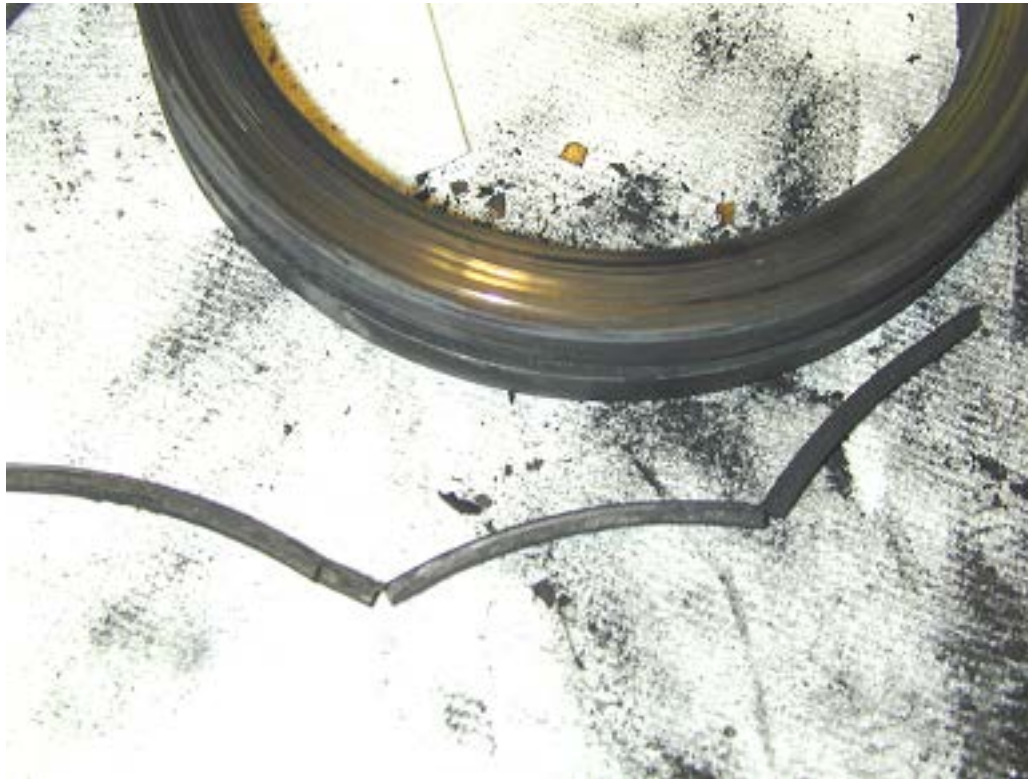
Seal elastomers damaged due to excessive heat generation from dynamic face contact

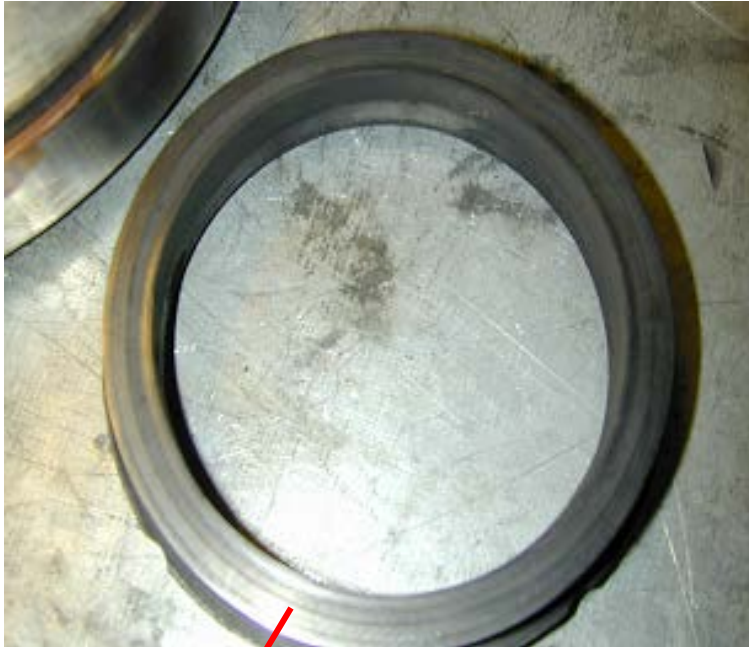
Inboard carbon primary ring deep grooves

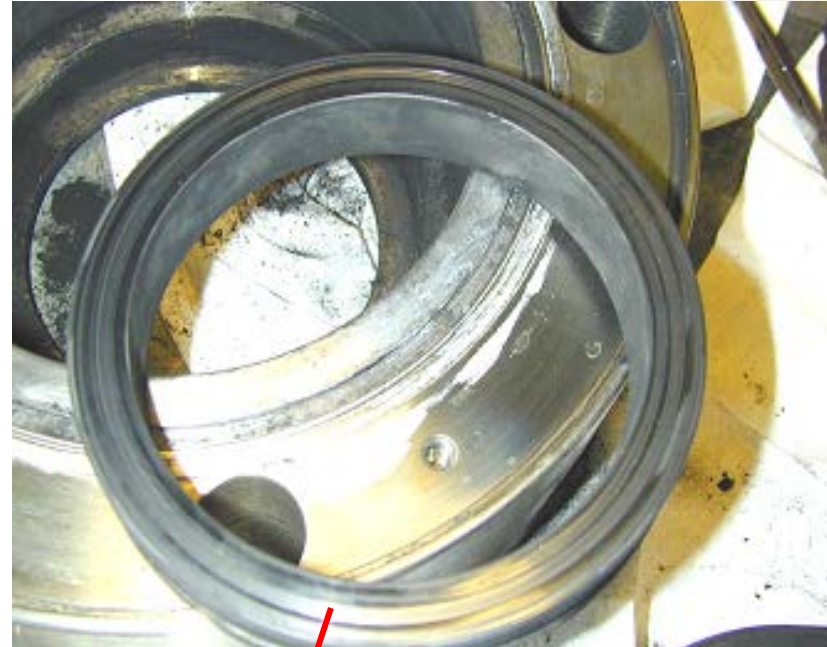
Outboard Mating Ring – Silicon Carbide severe abrasive wear
